Impervious Area Assessment

Harford County, MD Department of Public Works
Watershed Protection and Restoration
Watershed Restoration Status (MS4 Permit 11-DP-3310)

Watershed Restoration Project Monitoring - Woodbridge

Woodbridge Year 1 Post-construction Monitoring

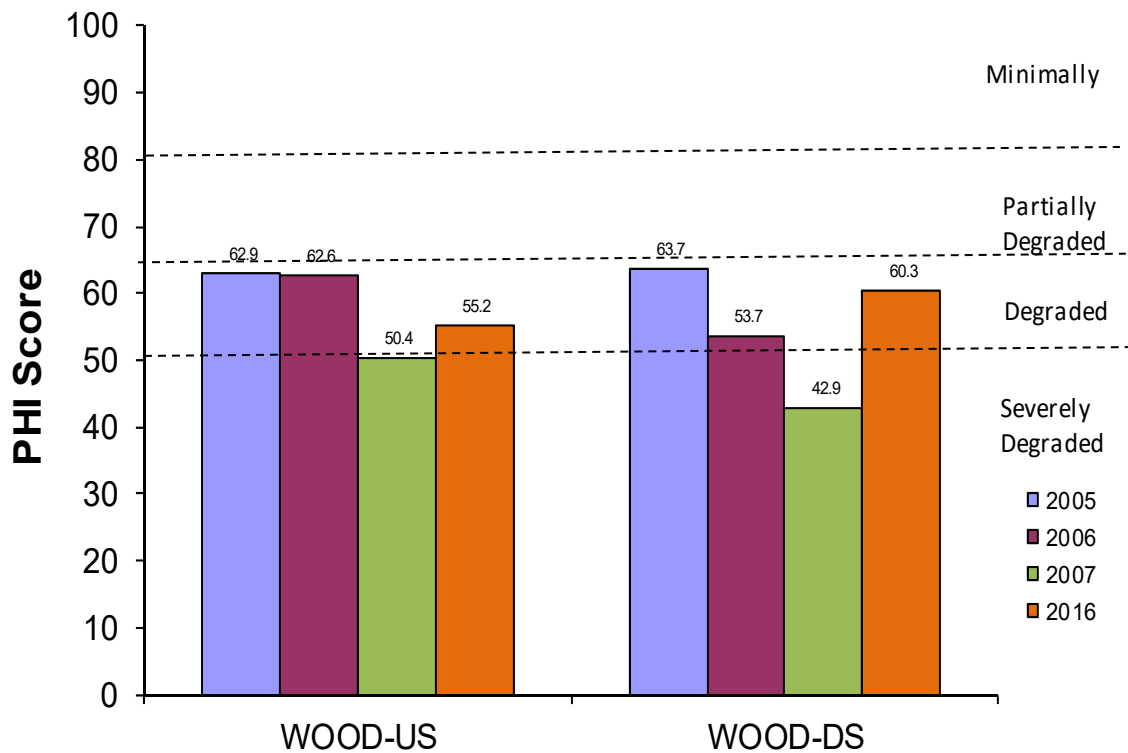
Figure 3. Comparison with Pre-Construction (2005-2007) PHI Scores

A comparison of post-construction results from 2015, to pre-construction data from 2005 – 2007 is presented below in Figure 3. Both sites show slightly improved PHI scores compared with pre-construction conditions. There is no longer a downward trend of declining habitat scores, most of which were previously attributed to accelerated bank erosion and sedimentation. It is likely that the PHI scores will improve once the vegetation begins to fill in, improving shading and woody input to the stream channel.

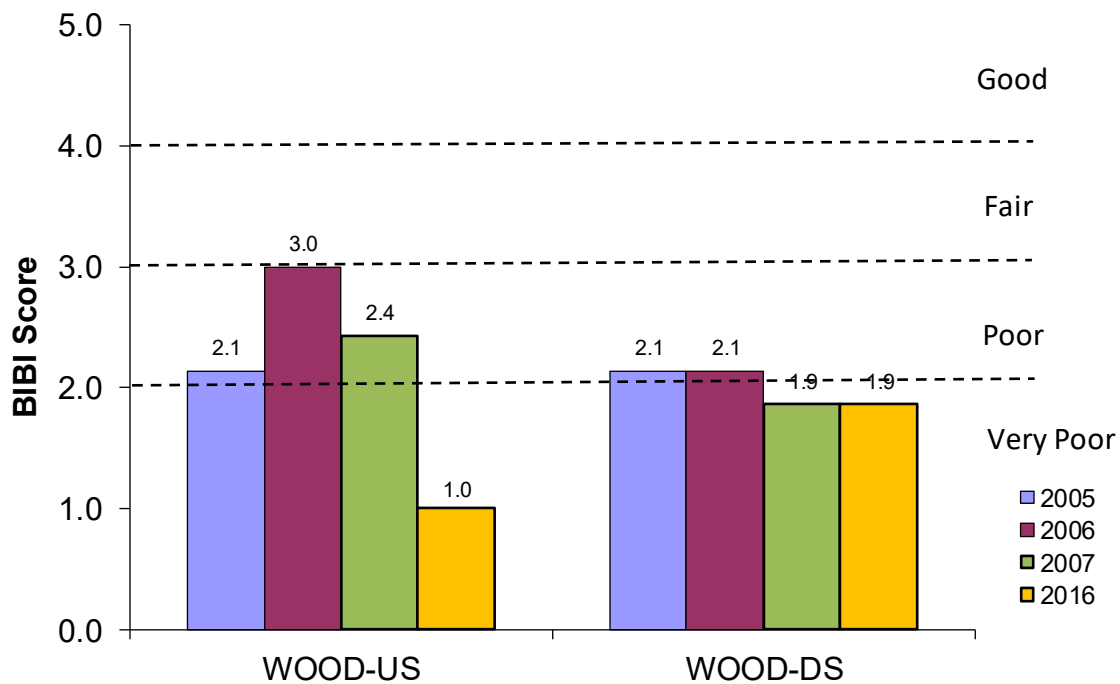
Figure 4. Comparison with Pre-Construction (2005-2007) BIBI Scores

A comparison of post-construction results from 2015, to pre-construction data from 2005 – 2007 is presented below in Figure 4. It is important to note that both sites had to be shifted slightly in 2015 from the previously established locations as a result of the stream restoration activities. The upstream site was shifted from above Magnolia Road in the pre-restoration phase to immediately below Magnolia Road in the post-restoration phase. Therefore, comparisons in BIBI scores between pre- and post-construction periods need to account for this difference. WOOD-DS shows fairly consistent BIBI scores from pre- to post-construction conditions. WOOD-US, on the other hand, shows a decline in post-construction BIBI scores. However, even at the reference site, deviations occur in the BIBI scores from year-to-year resulting from natural variation (see Figure 5). Although, it is also likely that the BIBI scores will improve once the benthic macroinvertebrate community has an opportunity to recover from the disturbance caused by the stream construction.

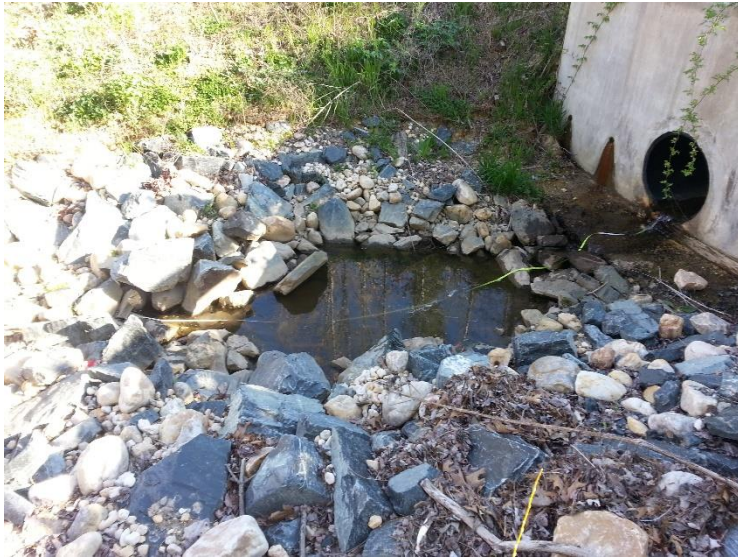
Station 0+10 facing left bank; possibly dislodged stones from pool

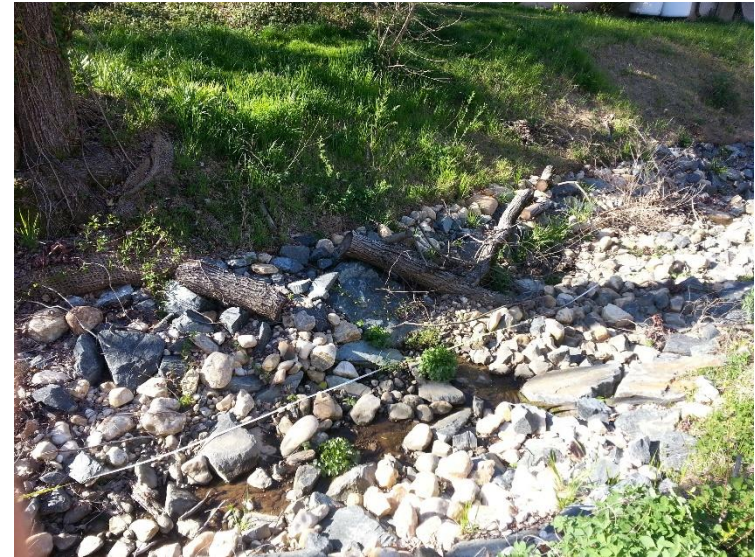
Station 0+80 facing left bank; cut tree in channel

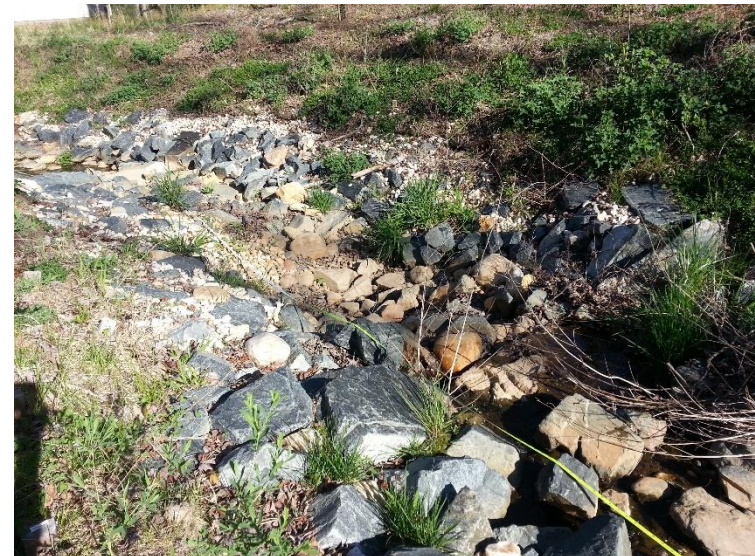
Station 2+25 facing right bank; pool and downstream riffle are dry

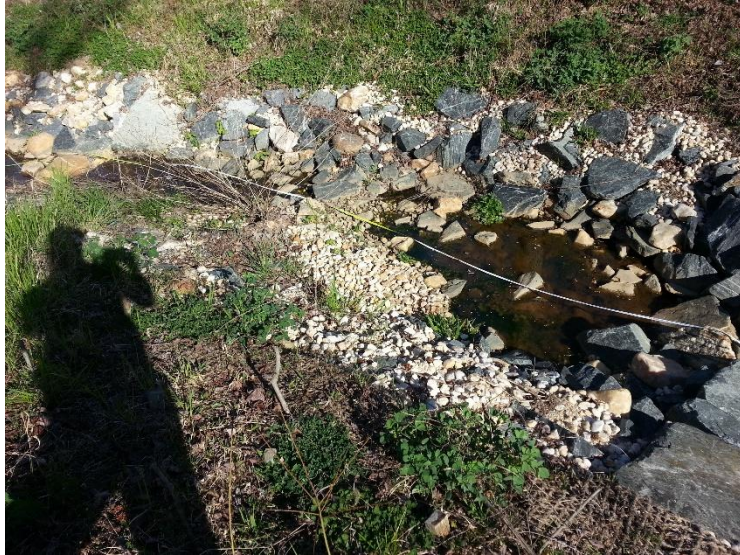
Station 2+50 facing right bank; cobble material potentially pushed up/out of pool

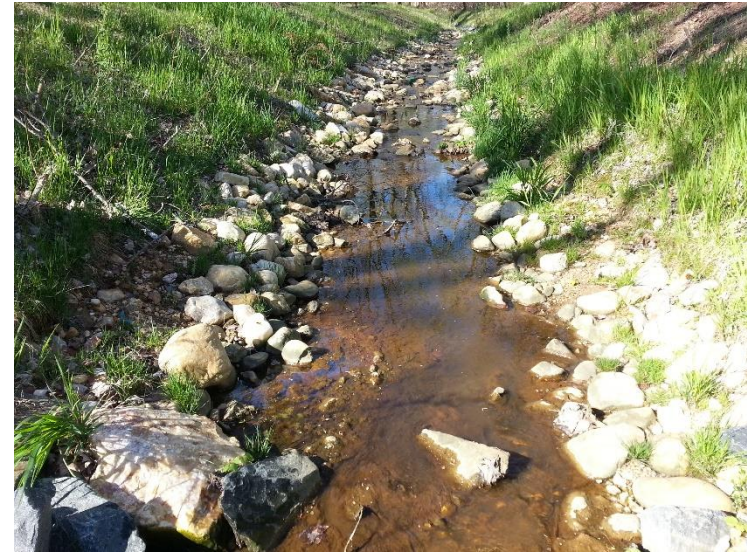
Station 3+50 facing downstream; minor left bank scour just downstream of riffle grade control

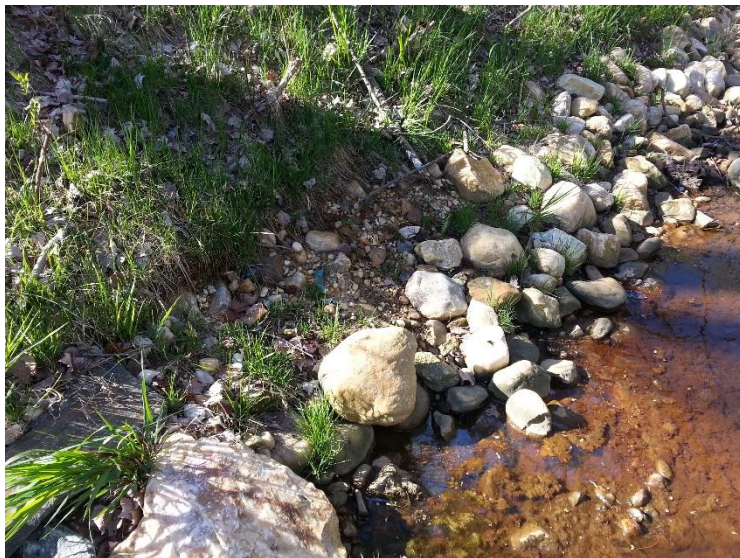
Station 3+50 facing left bank; minor bank scour just downstream of riffle grade control

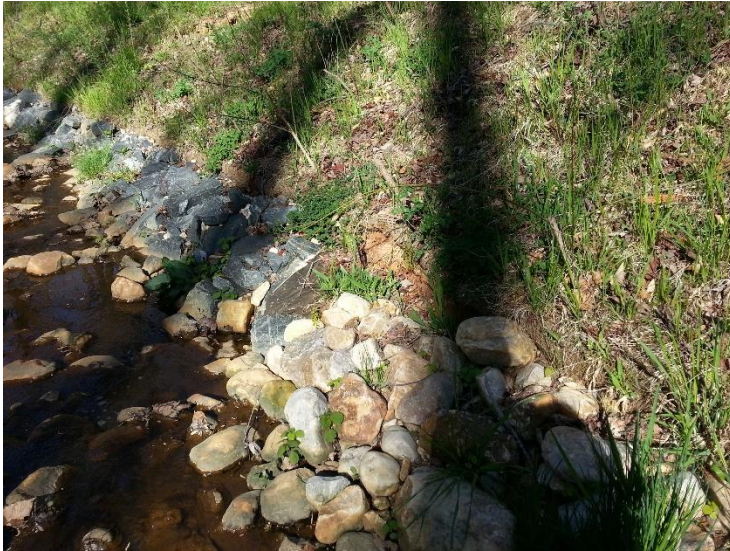
Station 4+65 facing right bank stone toe protection; small scour at key-in but cause uncertain, otherwise stable

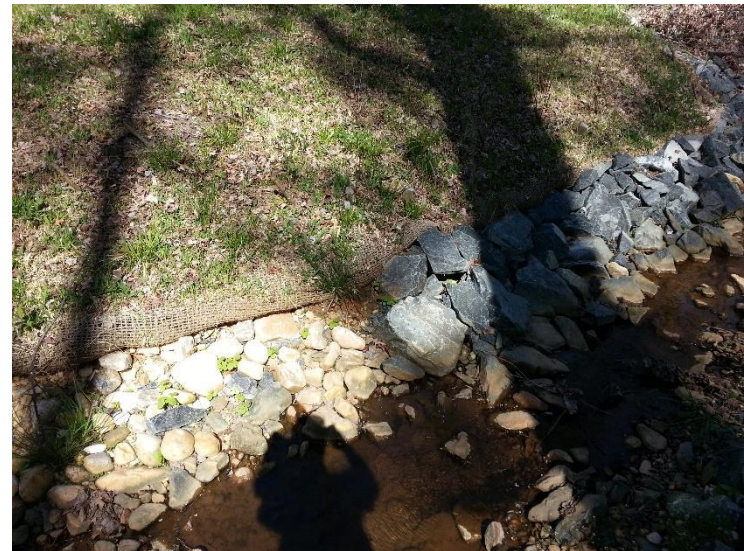
Station 5+80 facing right bank; stone toe protection tie-in a little perched

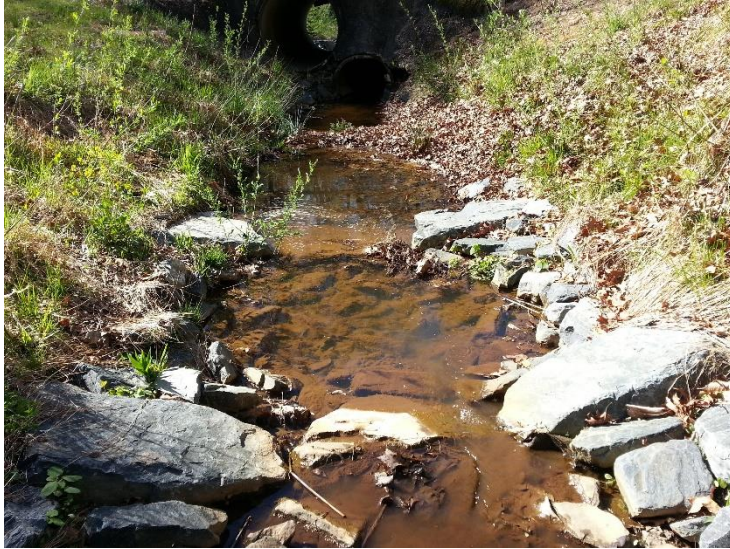
A series of three step pools were placed from 8+18 to 8+51 with crests at stations 8+18, 8+26, 8+34, 8+42, and 8+51. Each crest was observed to be stable, however, most of the pools were partially or fully filled with fine sediments or leaf litter. This is not anticipated to affect the stability as this material will be easily mobilized during a high flow event when the pools are scoured and needed for energy dissipation.

Station 8+27 facing downstream; weir 1 and weir 2 are stable; pool 1 is filled

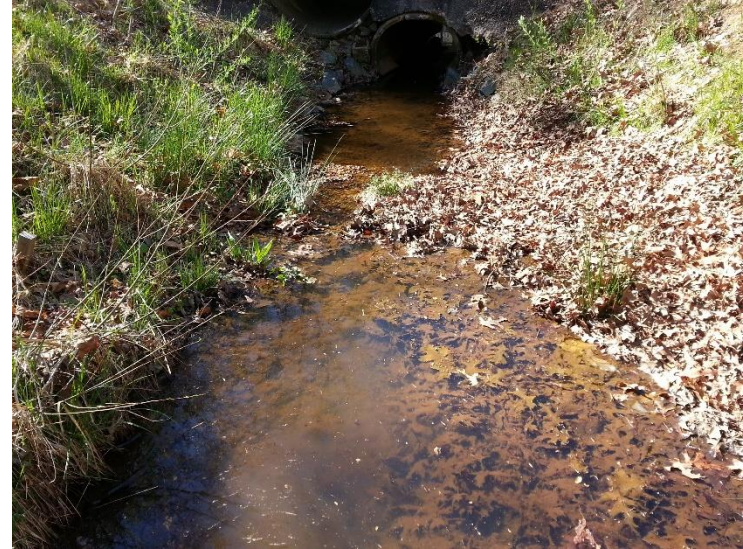
Station 8+50 facing downstream; pool 2 is not visible (same depth); weir 3 is stable, but has gravel and leaves on top

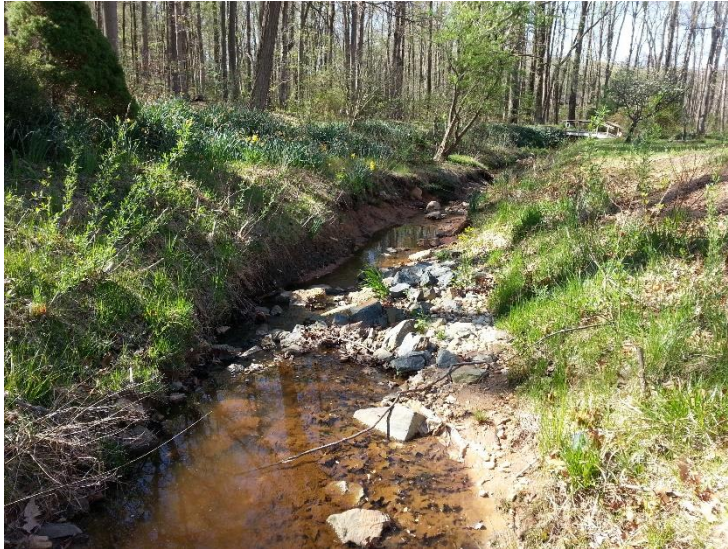
Station 9+25 facing downstream; material in channel likely causing minor left bank scour

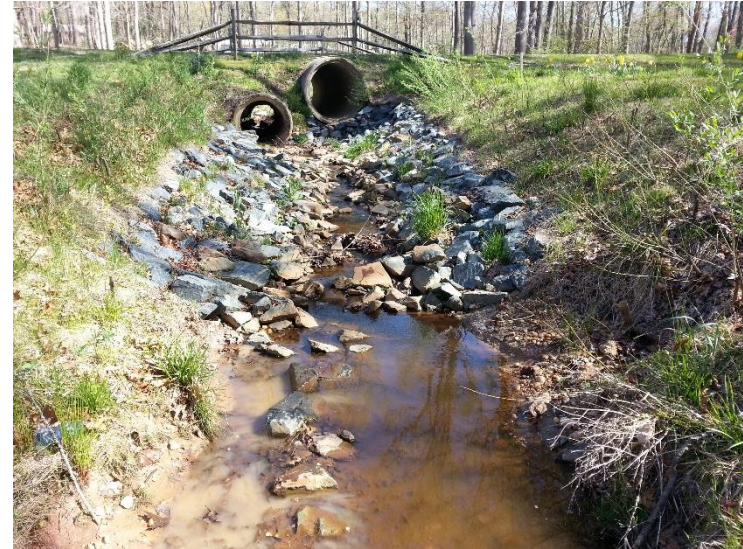
Station 9+25 facing upstream; downstream tie-in of riffle grade control to existing stream bed slightly elevated

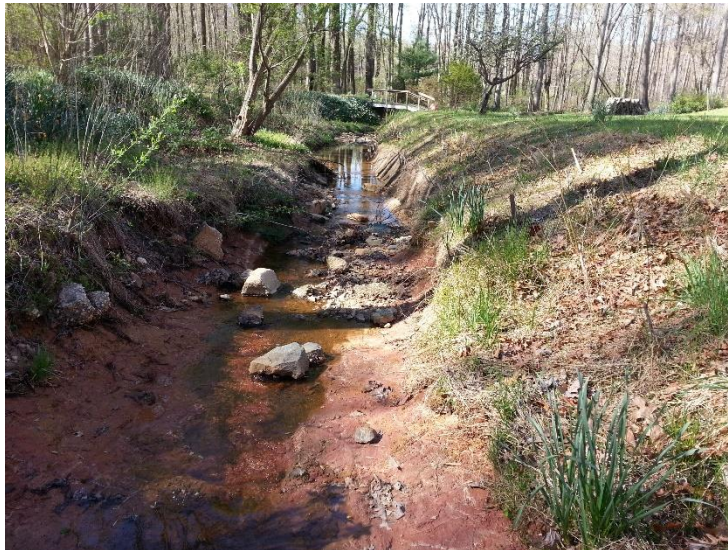
Station 9+75 facing downstream; about 40' of no work area is degraded

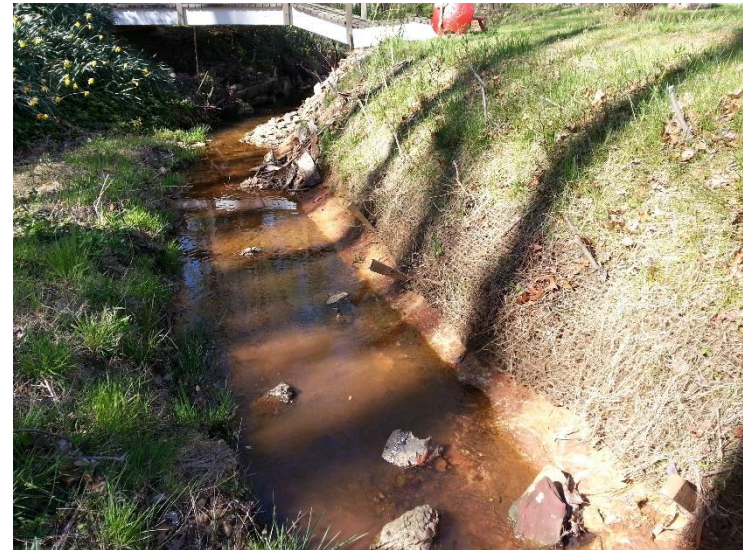
Station 10+40 facing downstream; landscaping stakes present should be pounded into bank or removed and cut fabric; clay toe is stable

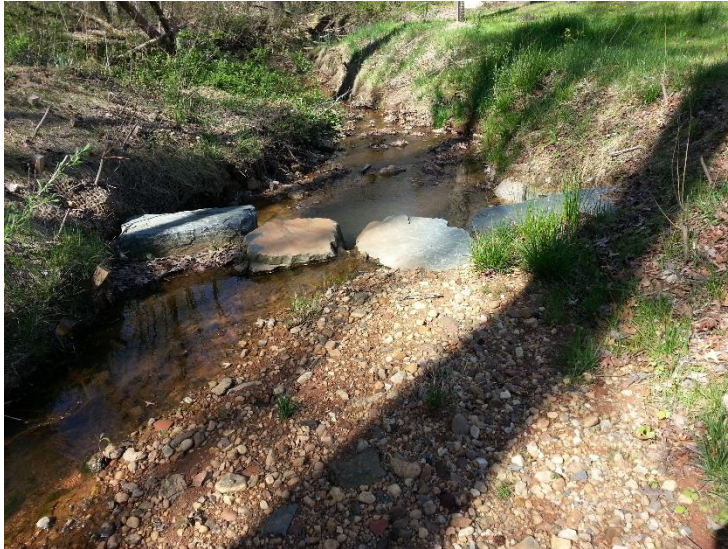
Stone sills were constructed at stations 9+00 and 12+00. The sill at 9+00 is stable and the scour pool directly downstream is also stable. The sill at 12+00 is located at the downstream extent of the restoration project. This structure is not failing but it is showing some signs of possible instability. This includes the separation of the sill stones, slight tilt to one of the central stones and scour at the downstream side of the sill. Additionally, the weir was installed at grade to the downstream existing bed when constructed, however, a scour hole is now visible for 8 feet downstream of the sill with overall channel downcutting visible. The signs of instability in the sill may be a result of shifting based on stopping the overall channel downcutting that has occurred, which was the purpose of this structure.

Station 11+90 facing downstream; sill top stones have scour visible on left bank

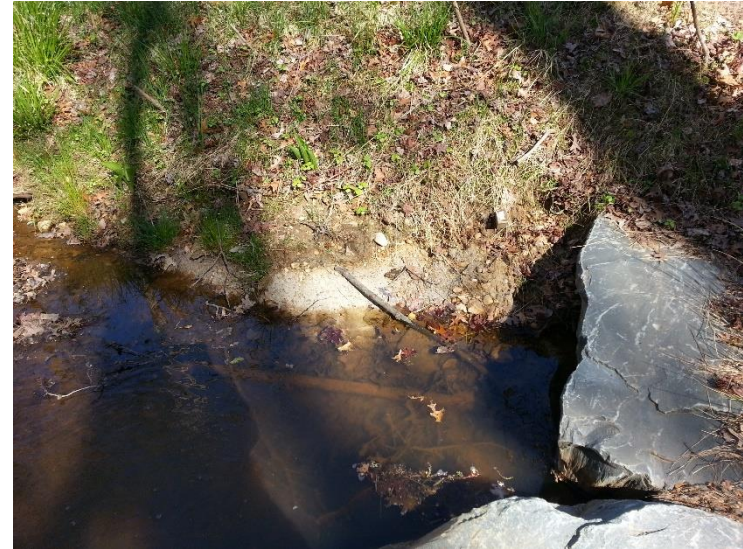
Station 12+00 facing right bank; scour downstream of sill

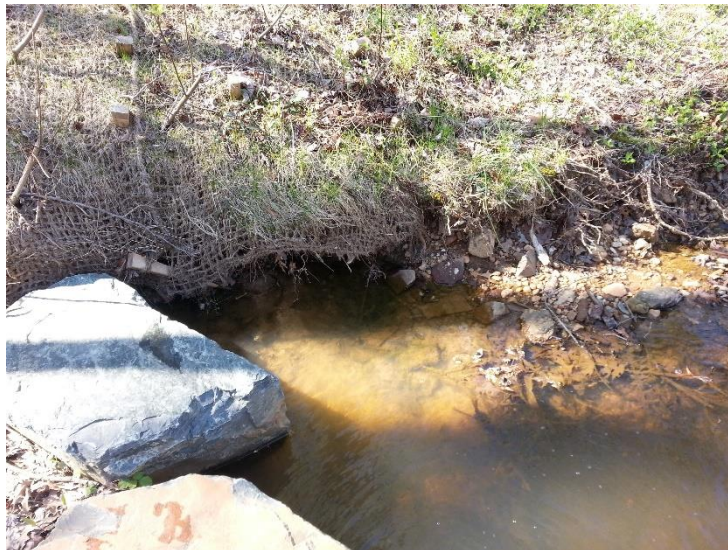
Station 12+00 facing left bank; scour downstream of sill

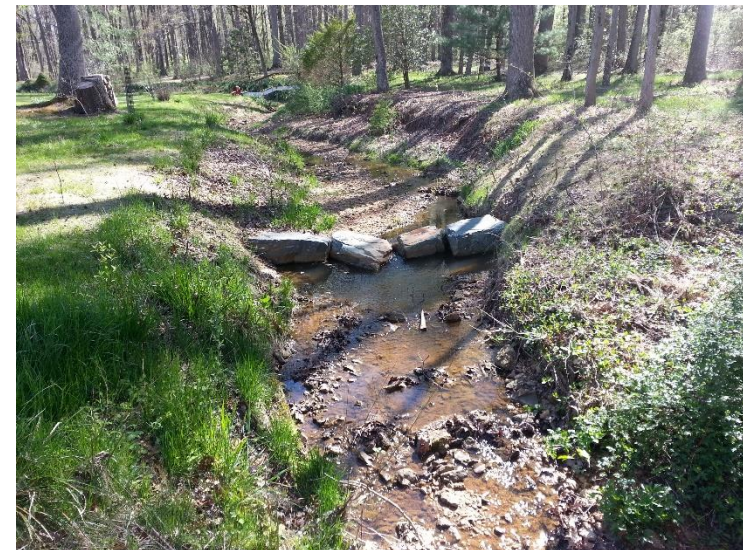
Station 12+15 facing upstream; scour downstream of sill on banks and bed
